NASA/TM—2005—212559

Debris/Ice/TPS Assessment and Integrated Photographic Analysis of Shuttle Mission STS-111

Author Name: Armando Oliu

June 2005

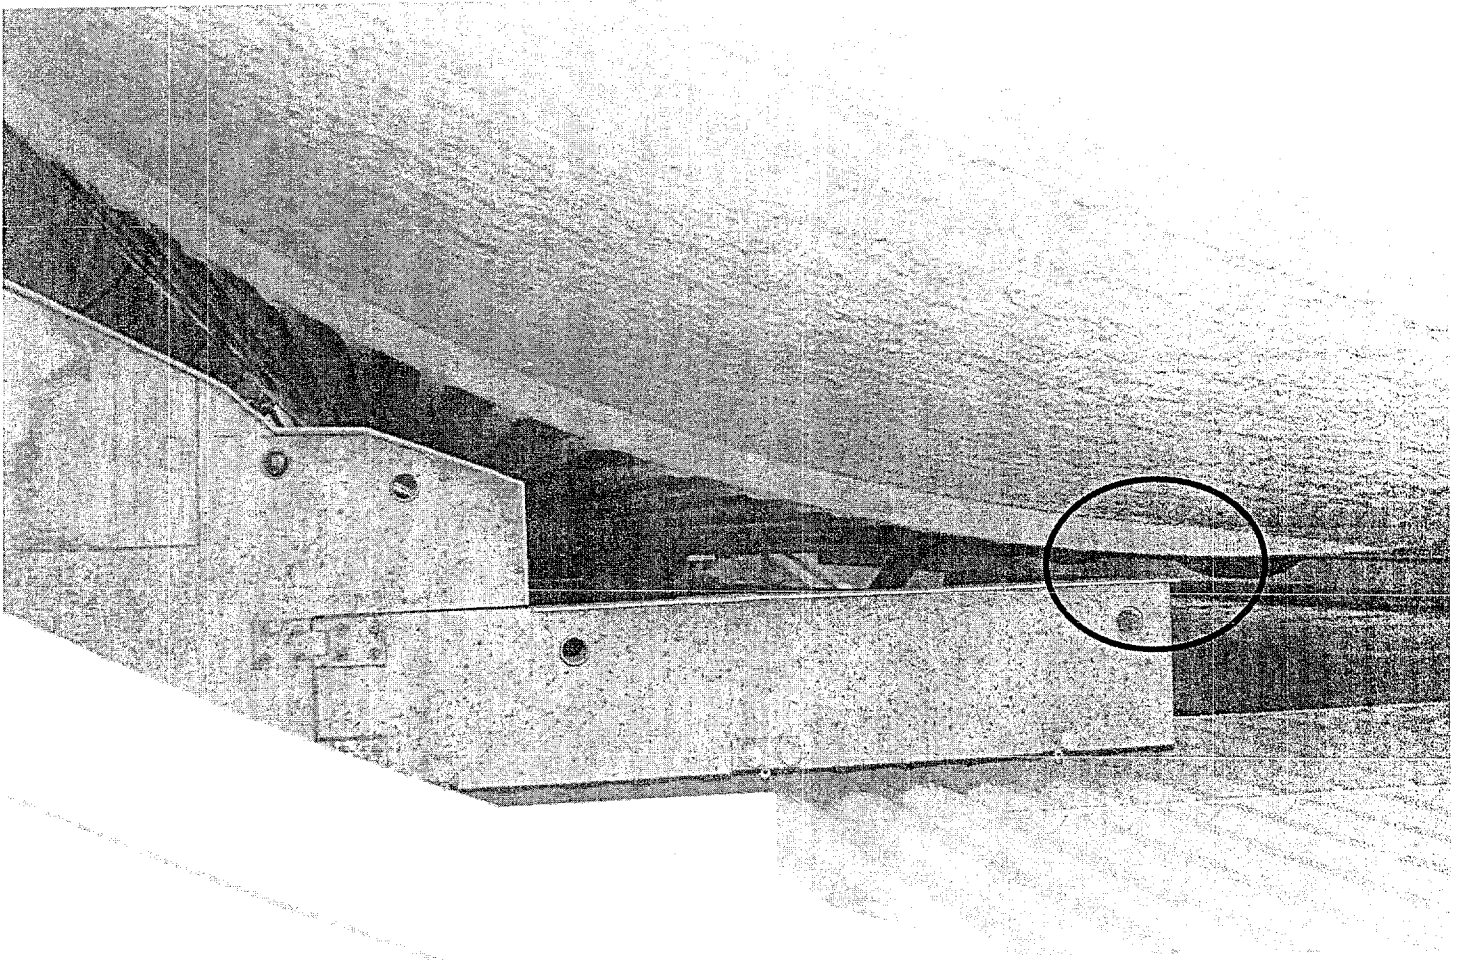
- -Y ET access platform flip is in down position. This flip needs to be raised prior to RSS retract. The end of the platform is within 3.5 inches of the External Tank.
- Excessive sand/debris on MLP deck and in gutter around MLP zero level.
- Two missing handrails (S2-16 and P4-1) and one broken pip pin (handrail S4-16) from removable handrails around the SRB exhaust hole. The handrails were already removed and were situated on the MLP deck. Pip pins need to be accounted for.

Photo 2: -Y ET access platform flip is in down position (out of configuration).
Clearance at closest point was less than 3.5 inches.

All items were in-work at the conclusion of walkdown. The configuration of the ET access platform was being corrected and the missing pip pins on handrails were located or accounted for.

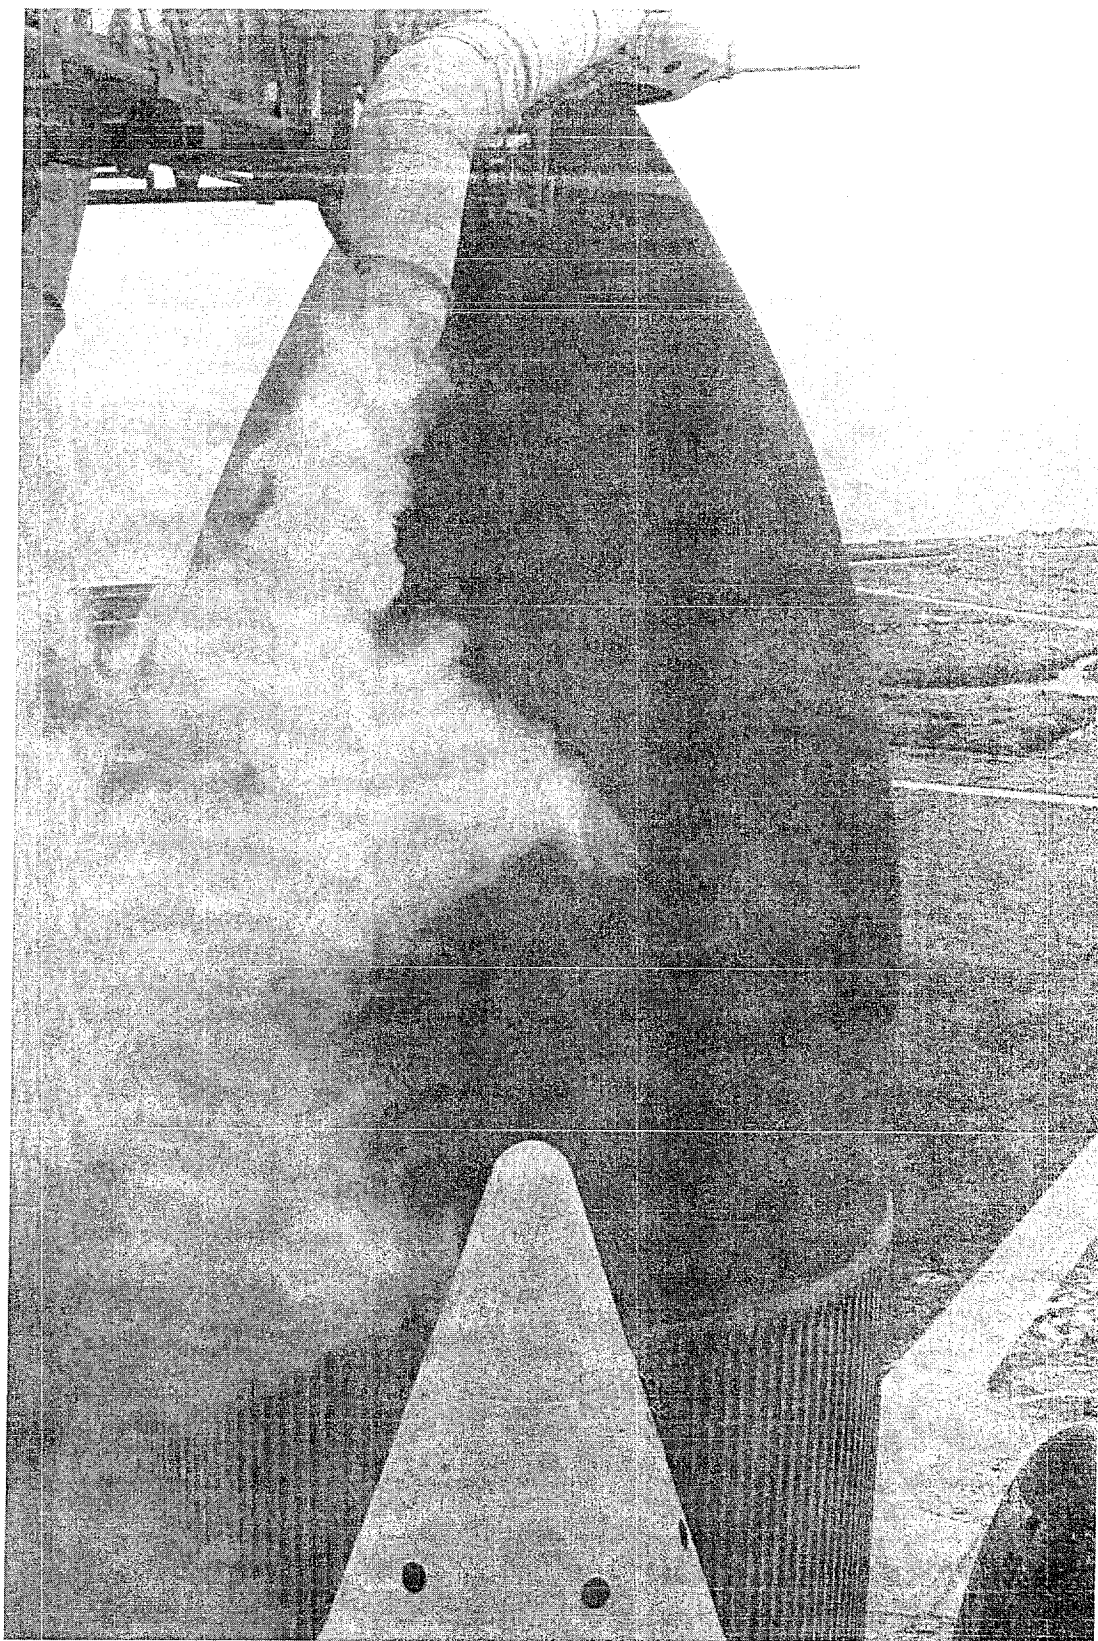
Photo 3: LO2 tank acreage.

Very little condensate was present on the LO2 tank acreage. Surface temperature ranged from 65 to 83 degrees Fahrenheit. There were no acreage TPS anomalies.

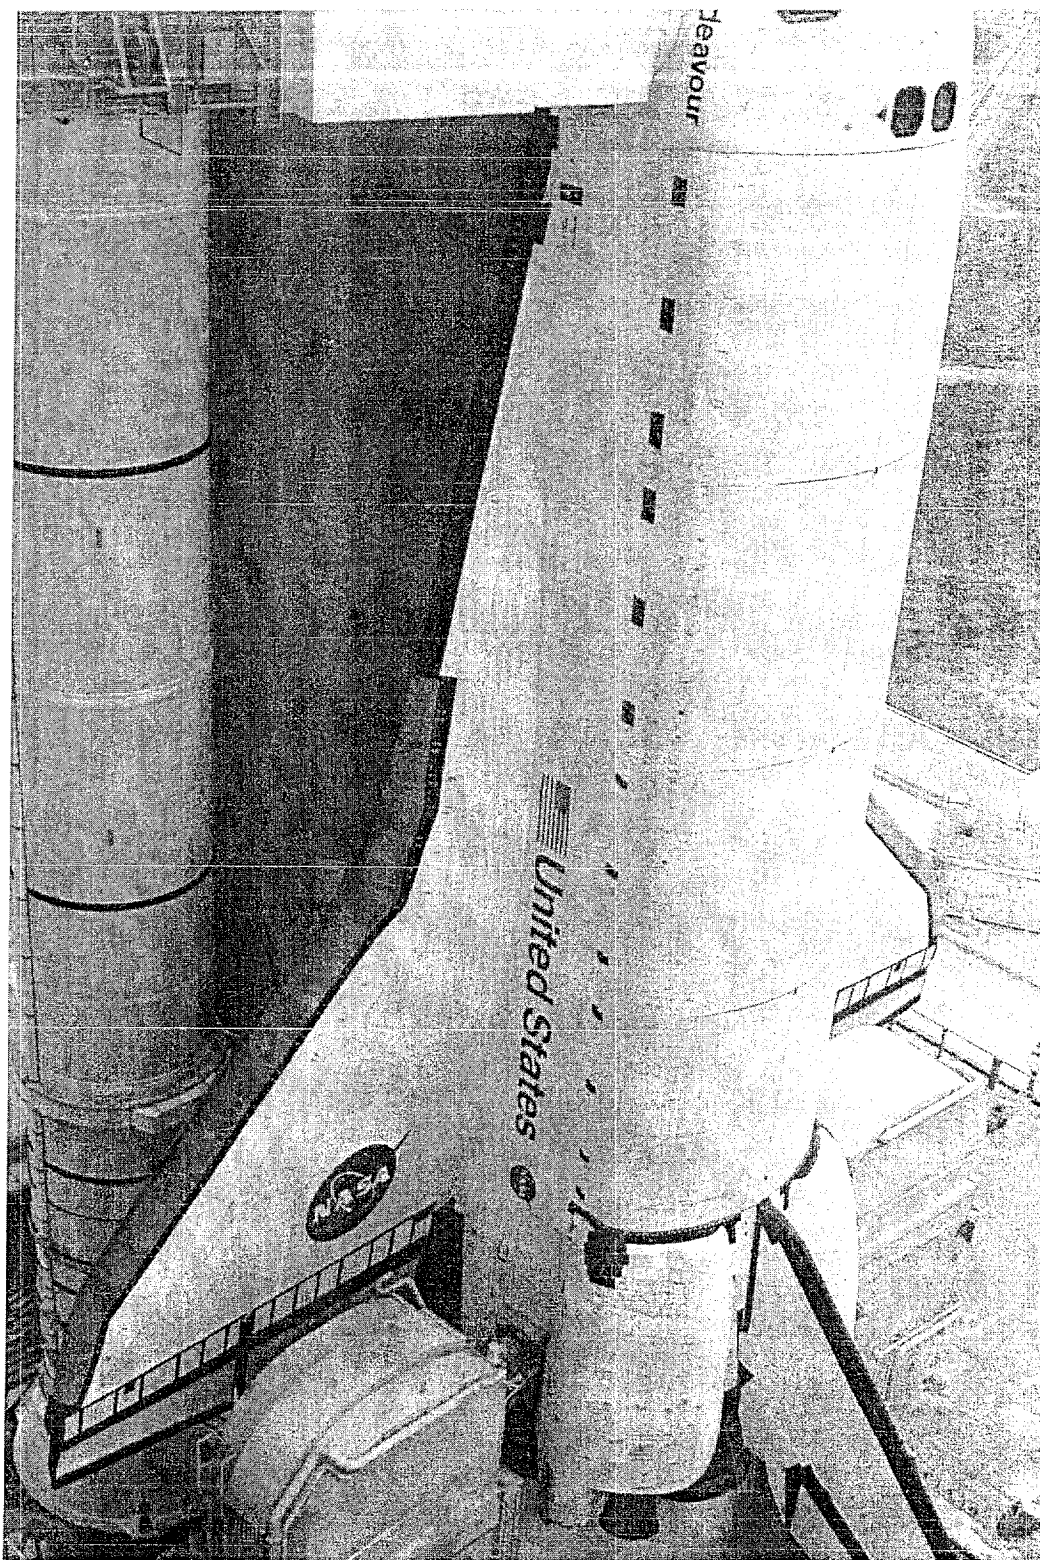
Photo 4: LH2 tank acreage.

The LH2 tank was wet with light condensate on the upper portion and moderate condensation at the aft end. Surface temperature ranged 64 to 83 degrees Fahrenheit. There were no acreage TPS anomalies.

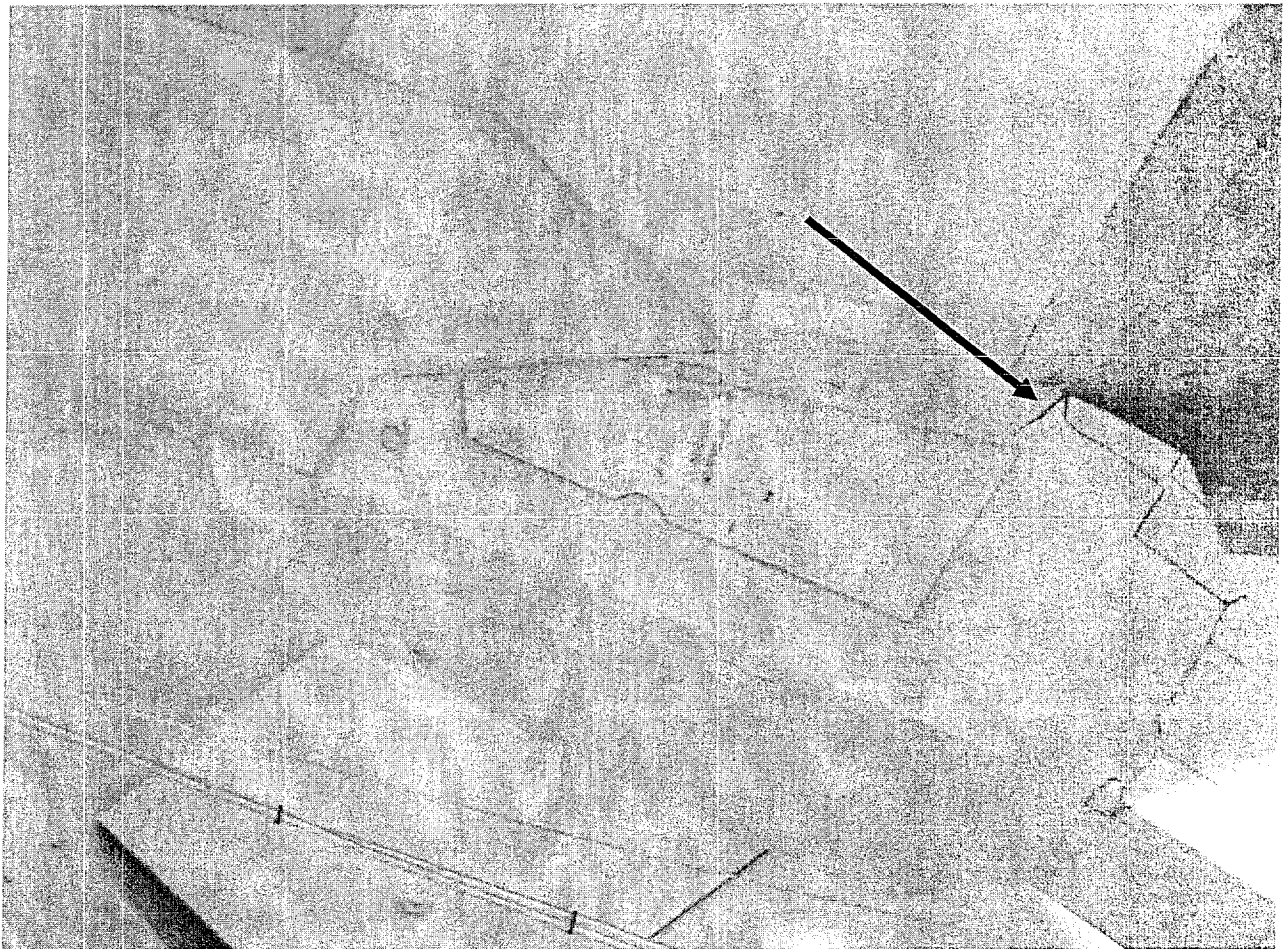
Photo 5: Crack in -Y Vertical Strut TPS

A 4 inch long and 1/4 inch wide stress relief crack was observed in the -Y vertical strut TPS with no offset. This condition has been observed on previous vehicles and found acceptable for flight per the NSTS-08303 criteria.

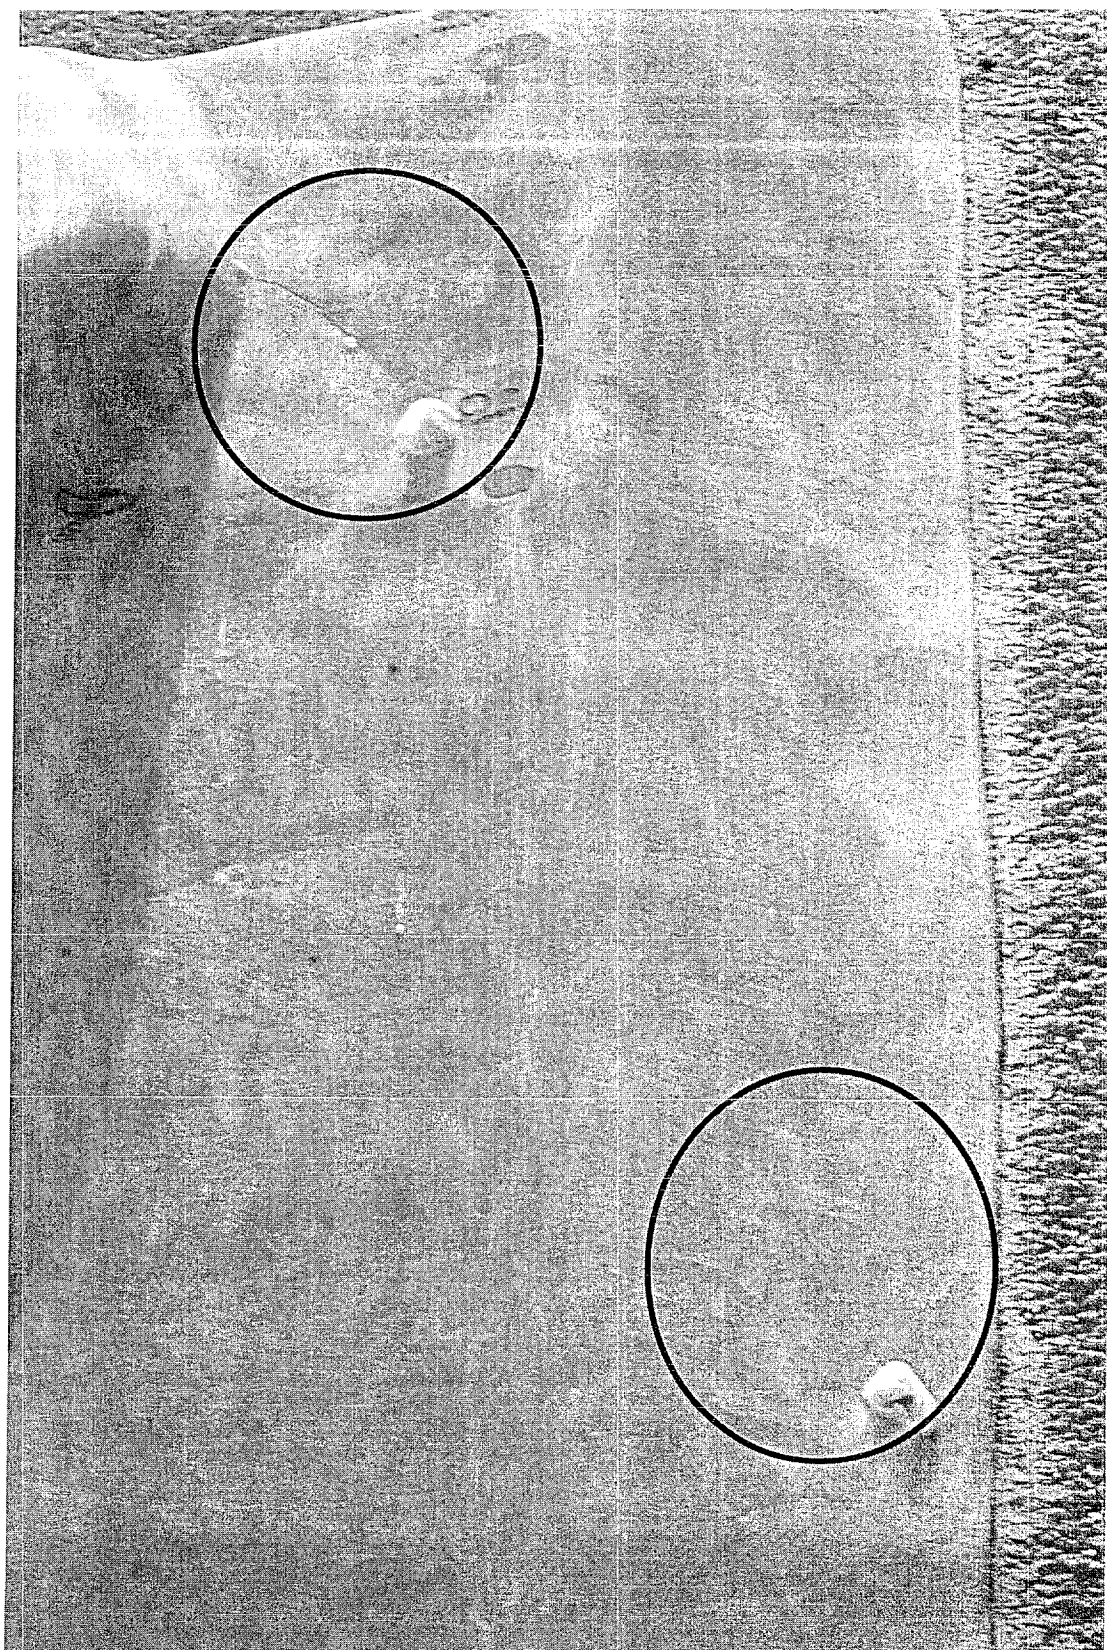
Photo 6: Cracks in +Y Longeron TPS closeout.

Two cracks were observed in the +Y longeron TPS closeout. The cracks also had 4 frost balls associated with them. IPR-111V-095 was generated since the condition is not covered in the NSTS-08303 Acceptance Criteria.

In the forward portion of the longeron closeout was a 12 inches long, with no measurable width (hairline), crack propagating diagonally aft. This crack had three frost spots associated with it. The second crack, located at the middle portion of the longeron closeout, was 12 inches long with no measurable width. This crack also propagated diagonally and had a frost ball at its aft end. Neither of the cracks followed knit lines or exhibited offset.

The cracks most likely resulted from a combination of typical thermal/mechanical induced TPS stresses and localized defects in the thick BX-250 closeout foam. An assessment was performed that consisted of two parts addressing the ET thermal/structural integrity for flight and possible debris threat to Orbiter lower surface tiles. With all the data taken, there was no evidence of debonds and the condition appeared to consist of shallow surface cracks only.

Since the cracks exhibited no offset, foam adhesion to substrate and sidewall longeron ribs provide adequate strength, which would preclude large pieces of debris from coming loose. Only normal ablation would occur. Aero/thermal simulation data showed no foam loss when shallow cracks were present in the material. Therefore, there was no threat from TPS debris nor was there any concern about ice debris since frost, but no ice, had formed in association with the cracks.

Two cracks were observed in the +Y longeron TPS closeout. The cracks also had 4 frost balls associated with them.

In conclusion, the condition was accepted for flight by MR.

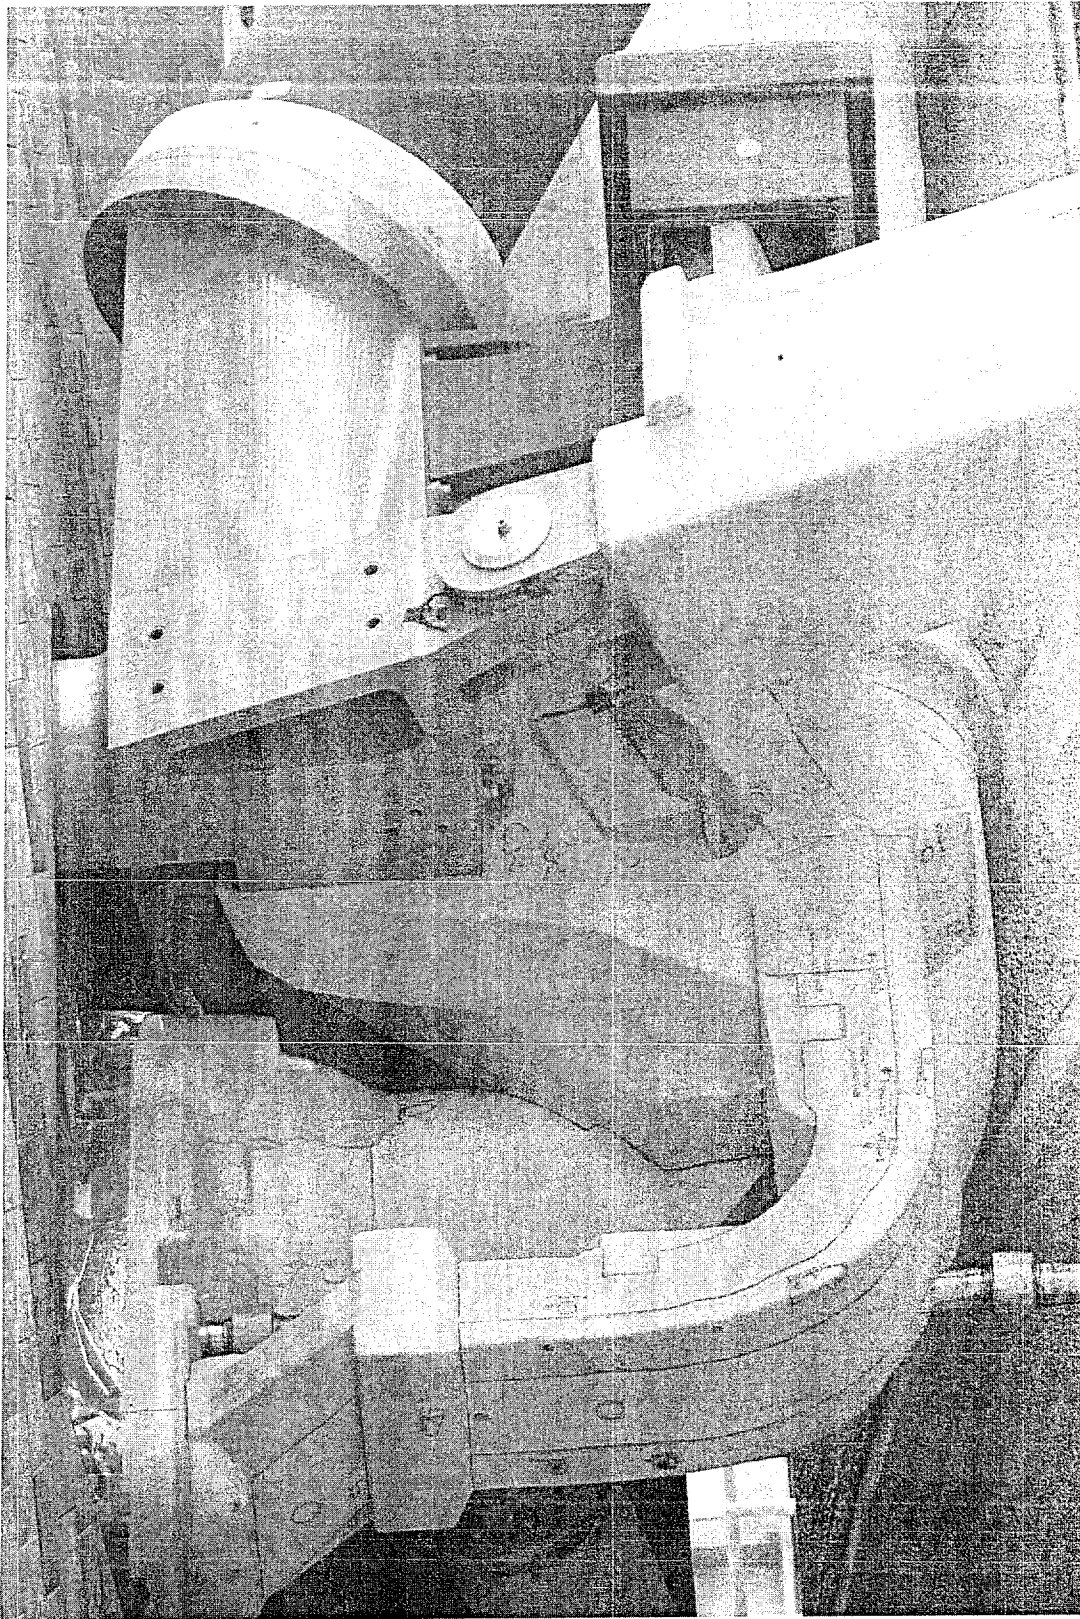
Photo 7: LO2 Umbilical area.
Ice/frost finger on pyro canister vent.

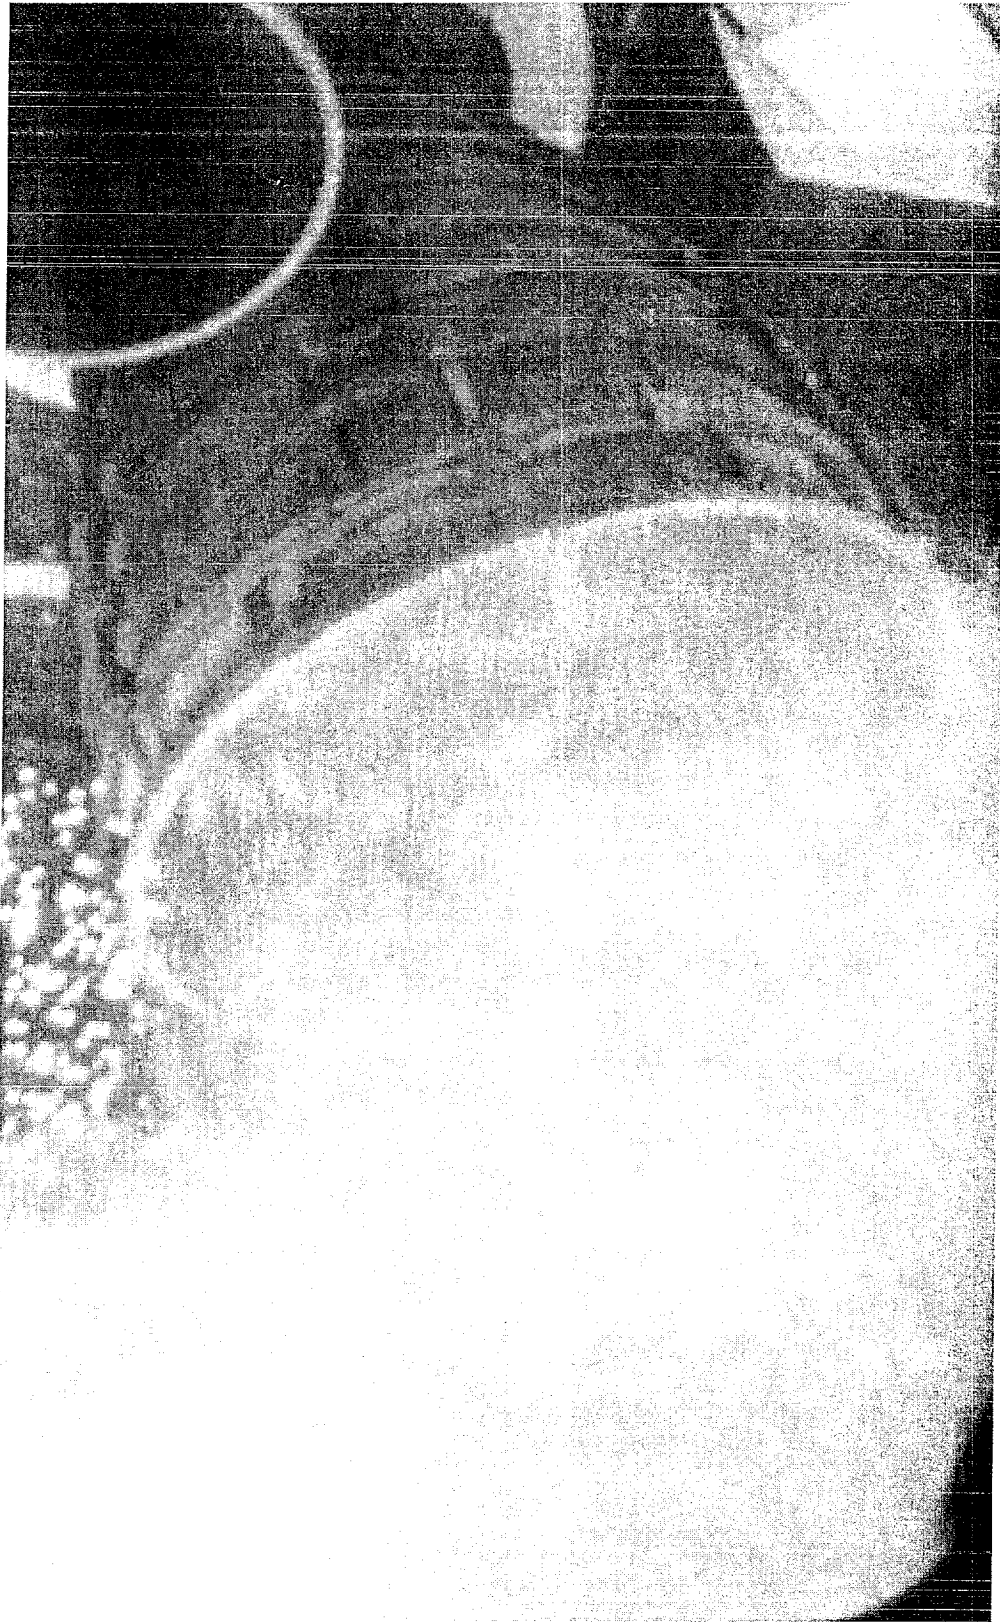
Free-burning GH2 blown under body flap by wind during SSME ignition.

Photo 8: SSME Flare approximately 1.5 seconds into startup sequence.

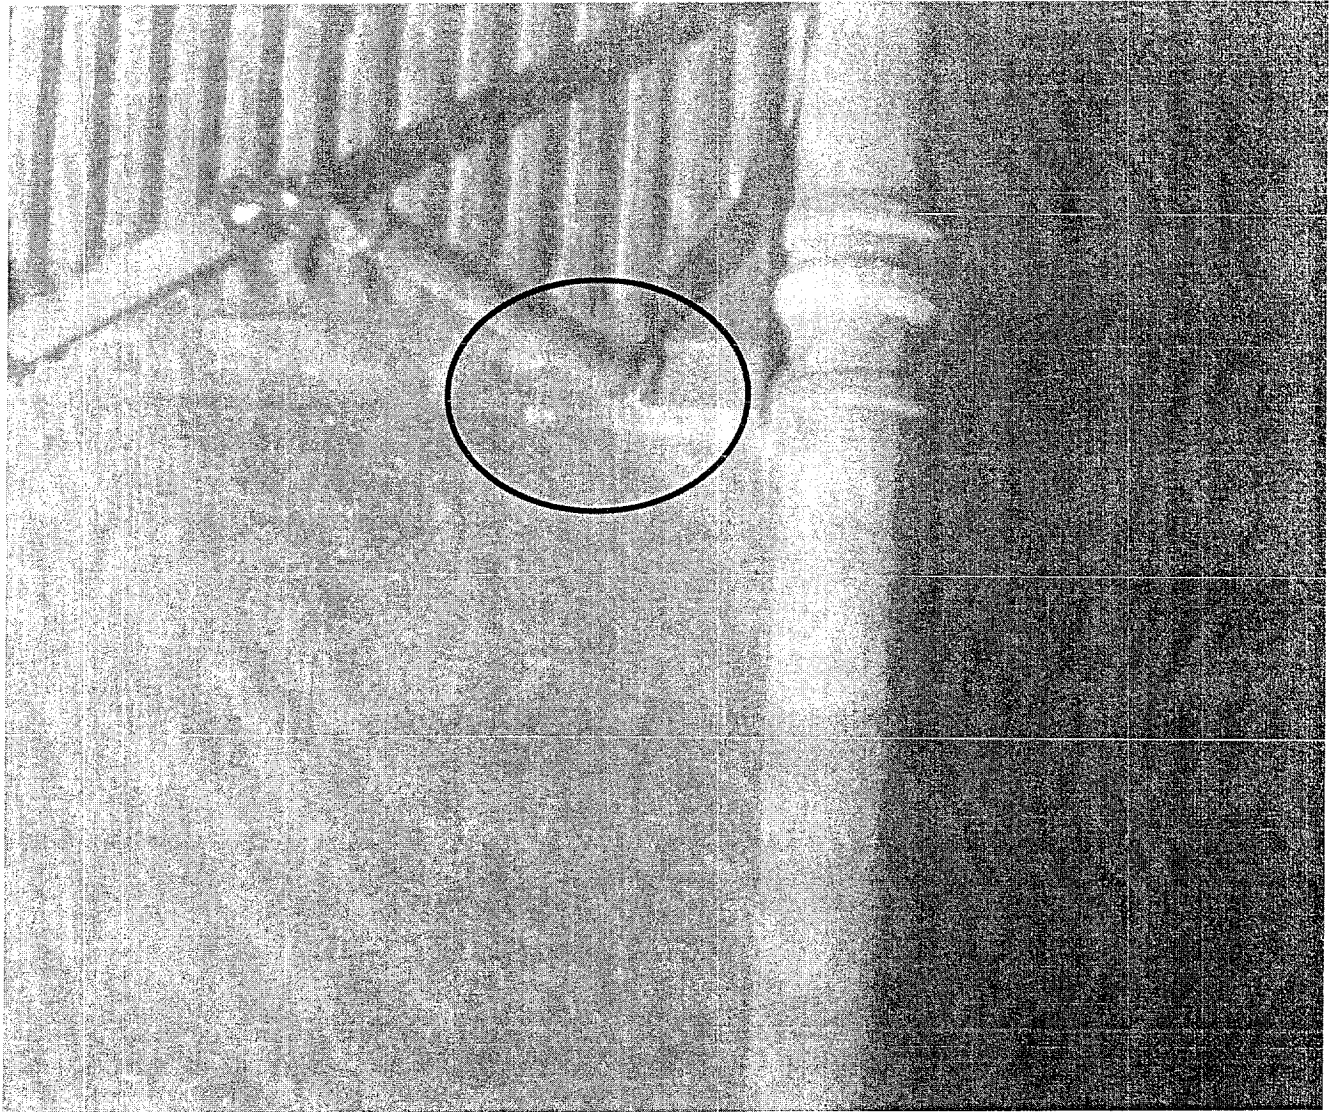
Photo 9: External Tank post-separation.

Three TPS divots, approximately 1.5 inches in diameter, were observed on the intertank-to-LH2 tank flange closeout near the +Y jack-pad closeout. One TPS divot, approximately 1.5 inches in diameter, was observed at the +Y bipod ramp-to-LH2 tank interface. The divots appeared shallow with no substrate exposed.

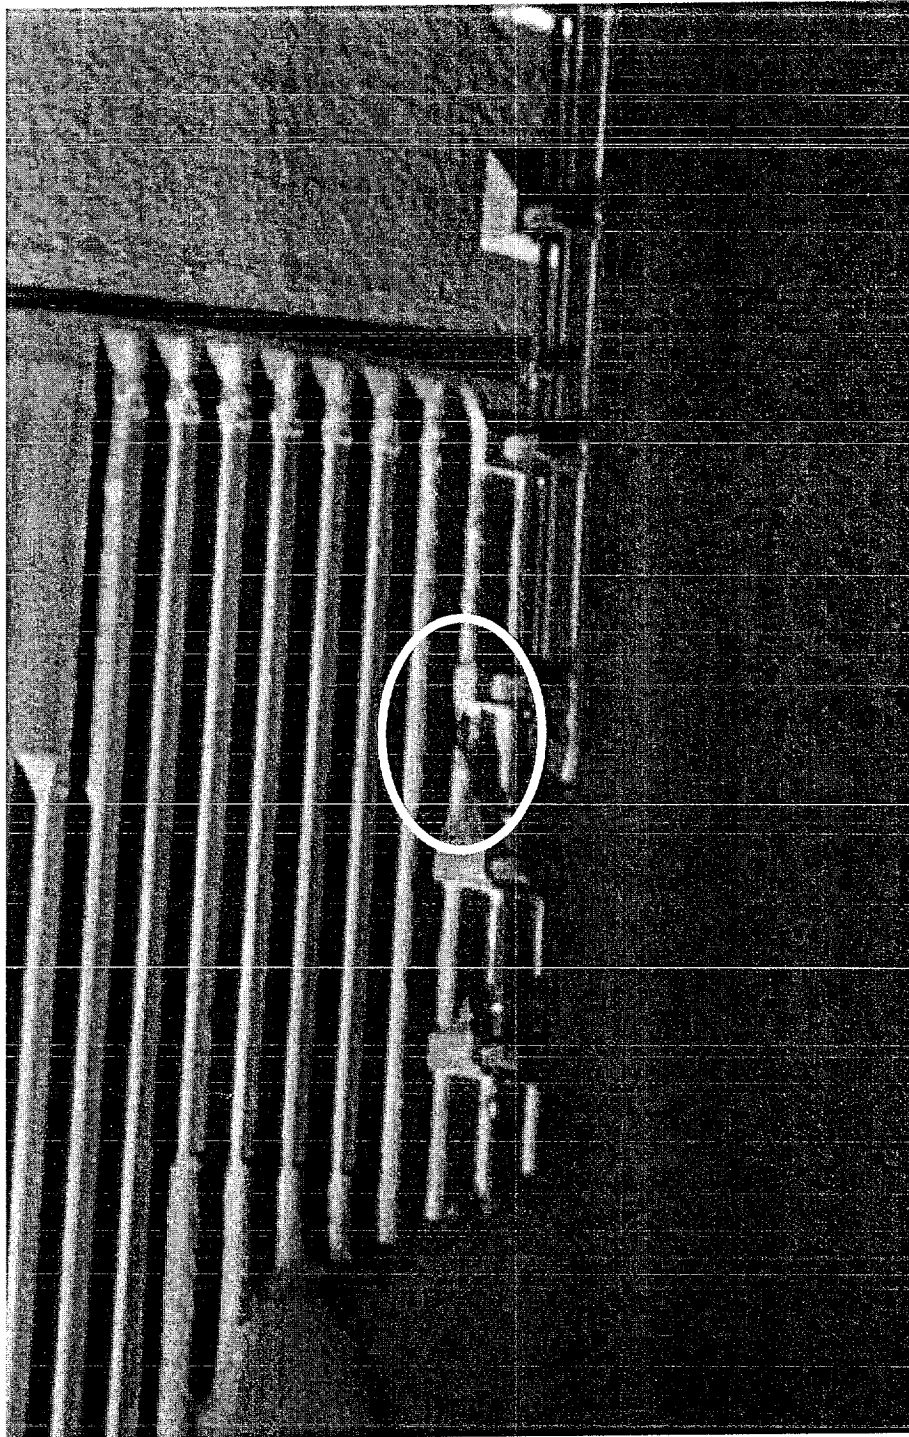
Photo 10: External Tank post-separation.

TPS divot (approximately 6 inches long by 2 inches wide) with exposed substrate located on an inter-tank stringer near the GO2 Press/Line ramp at station Xt -897.

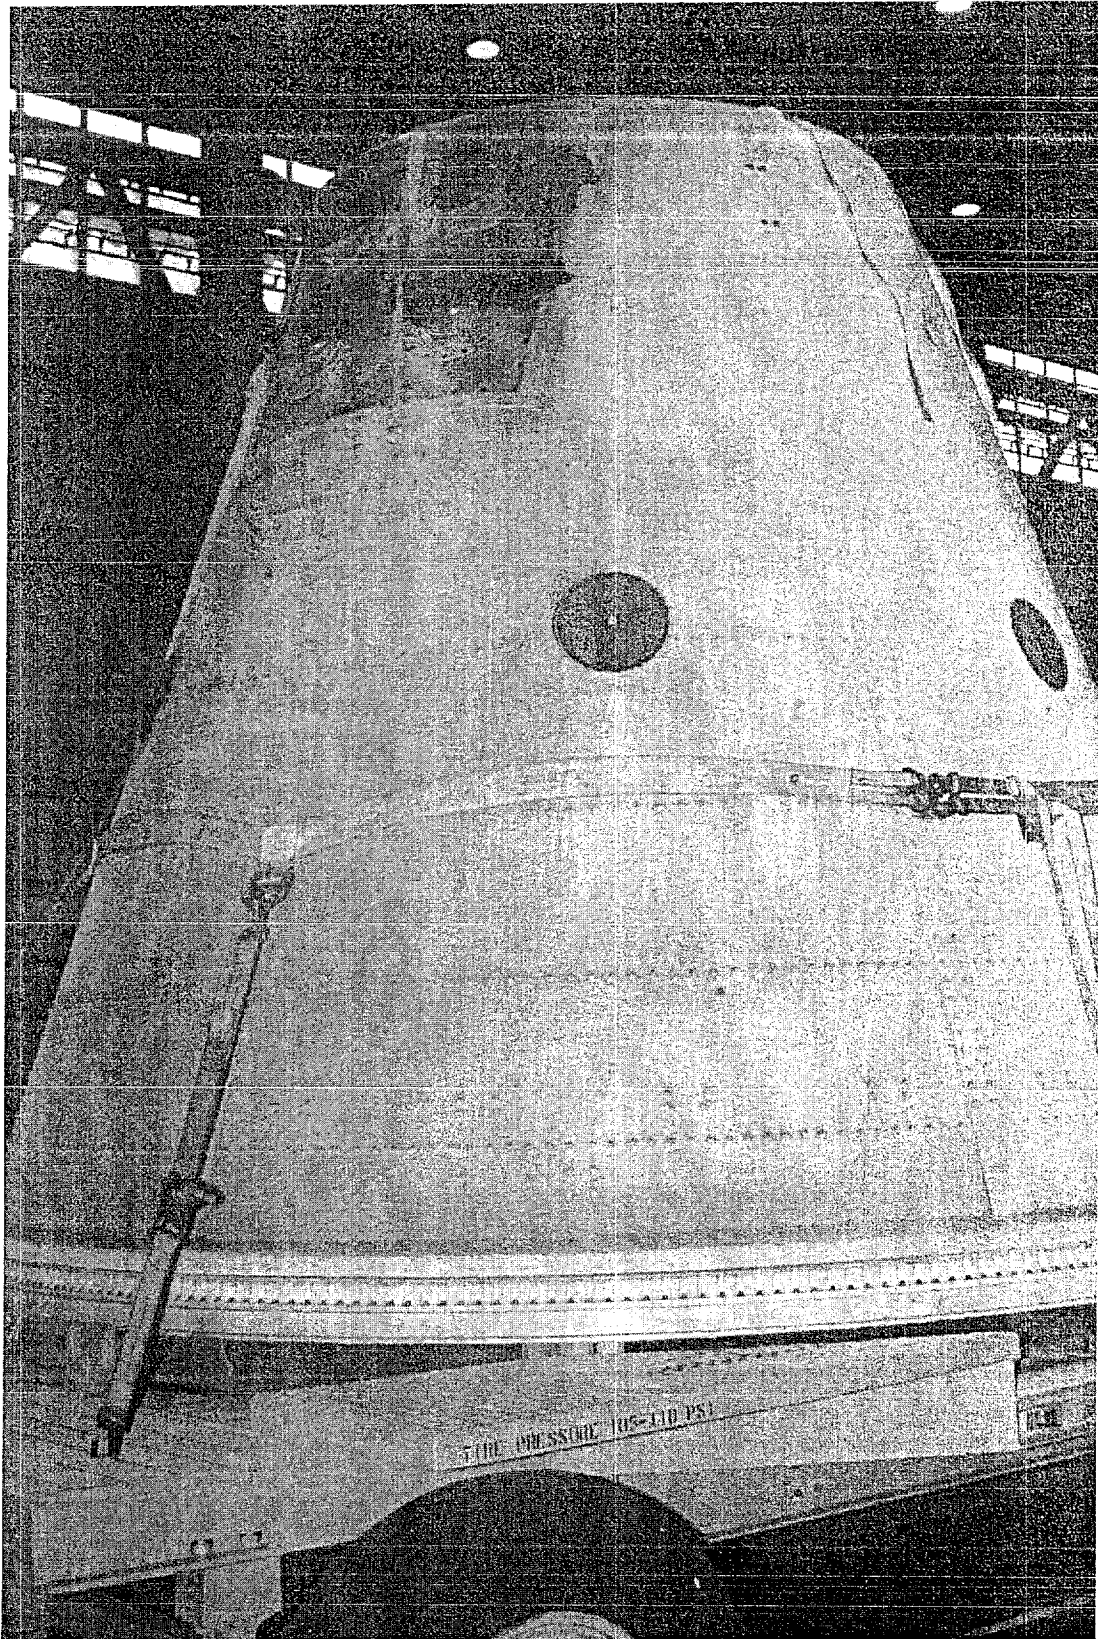
Photo 11: LH Frustum Post Flight Condition

The LH SRB frustum exhibited no debonds/unbonds or missing TPS.

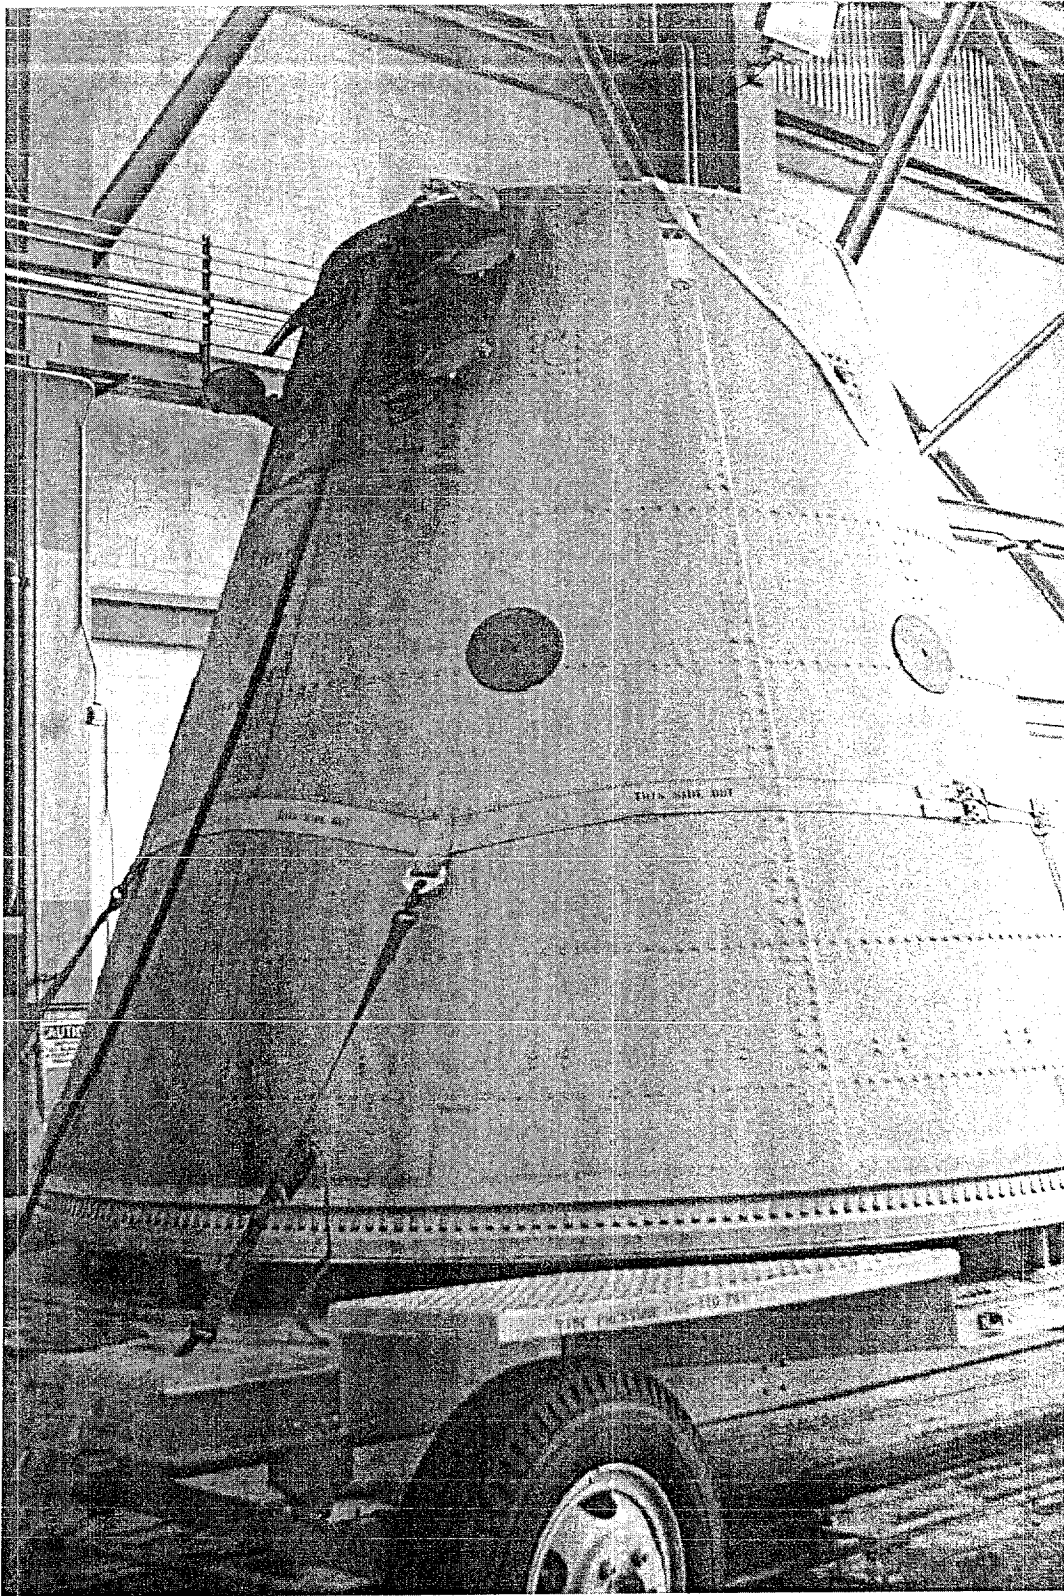
Photo 12: RH Frustum Post Flight Condition

The RH SRB frustum exhibited no debonds/unbonds or missing TPS. Note the cover attach ring bent at the hinge by parachute riser entanglement.

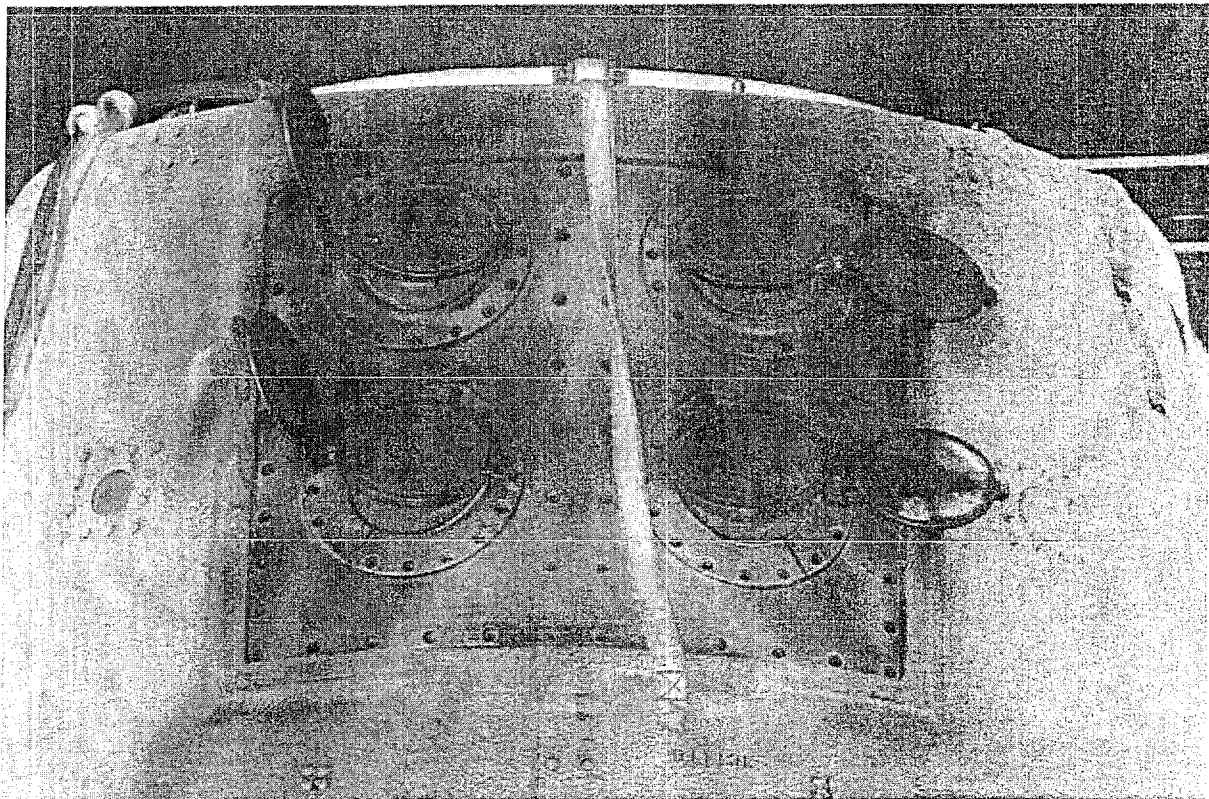
Photo 13: BSM Cover Condition

Two LH cover attach rings had been bent at the hinge by parachute riser entanglement.

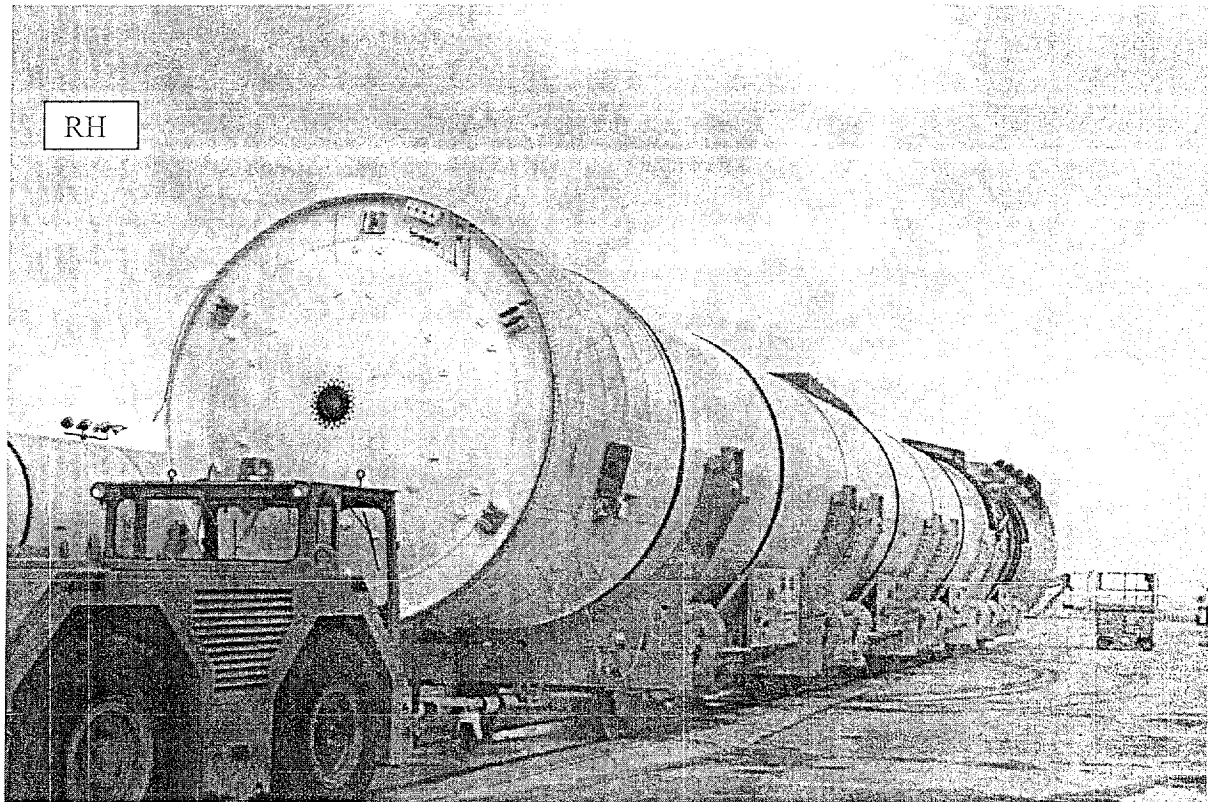
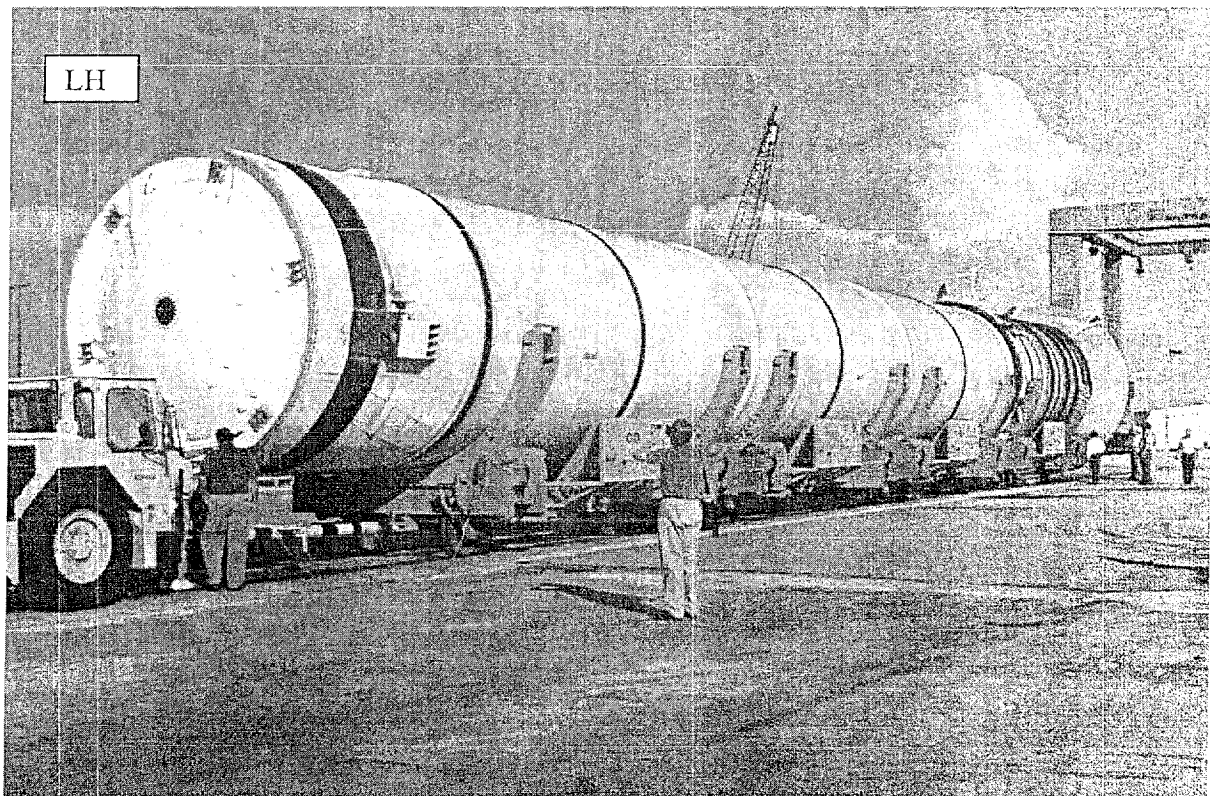
Photo 14: SRB Post Flight Condition

Both SRB's were found in good condition regarding debris assessment

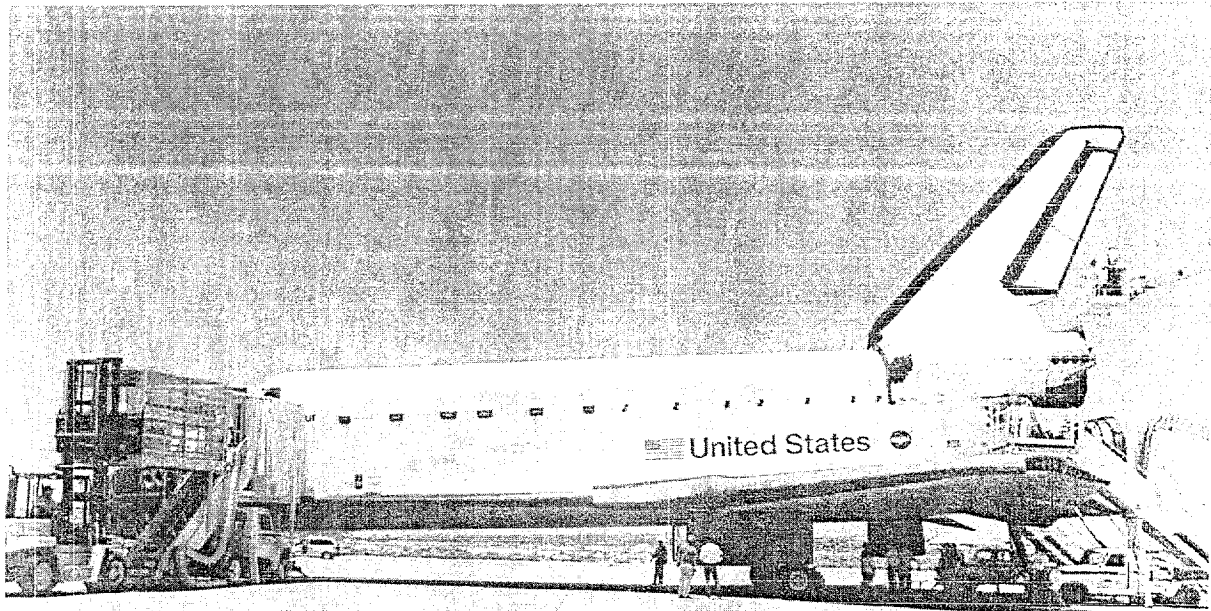
Photo 15: Overall View of Orbiter sides

The Orbiter lower surface sustained 47 total hits, of which 21 had a major dimension of one inch or larger. Both of these numbers are within family.

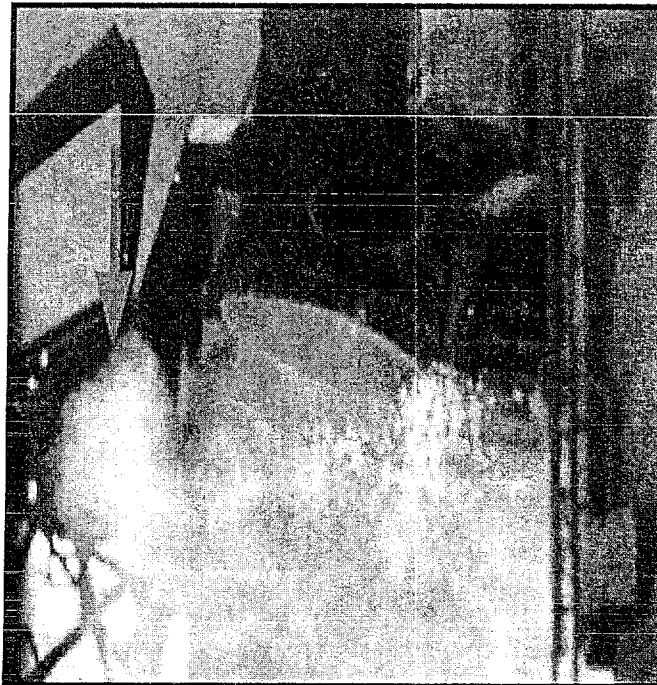
Figure 2.1 (A) Orange Flash Seen in SSME #1 During Ignition (Camera E2)

A large, late-occurring, orange-colored flash (probably free burning hydrogen) was seen in the +Z /-Y direction from the SSME #1 rim during SSME ignition (21:22:45.541 UTC). On the close-up camera E20 view, the flash appeared to originate within or just below the rim of SSME #1 (21:22:45.537 UTC). A second smaller flash was visible aft of the larger flash (Cameras E2, E19, E20, E52, E63, E76). The previous mission STS-110 launch video was reviewed and a similar but much smaller flash near SSME #1 was also present during the STS-110 SSME ignition. (The STS-110 flash occurred 1.5 seconds prior to the SSME #1 Mach diamond formation compared to STS-111 where the flash occurred 1.2 seconds prior to the SSME #1 Mach diamond formation.). No out-of-family flashes were seen on the STS-108 and STS-109 videos.
